PROJECT DOSSIER

BOGIBEEL RAIL CUM ROAD BRIDGE PROJECT

Project	BOGIBEEL RAIL CUM ROAD PROJECT
Location	Dhemaji & Dibrugarh District, Assam, India
Client	NEFR
Consultant	RITES
Contractor	Hindustan Construction Company
Designer	Ramboll
Duration	Sept 2018-Nov 2018

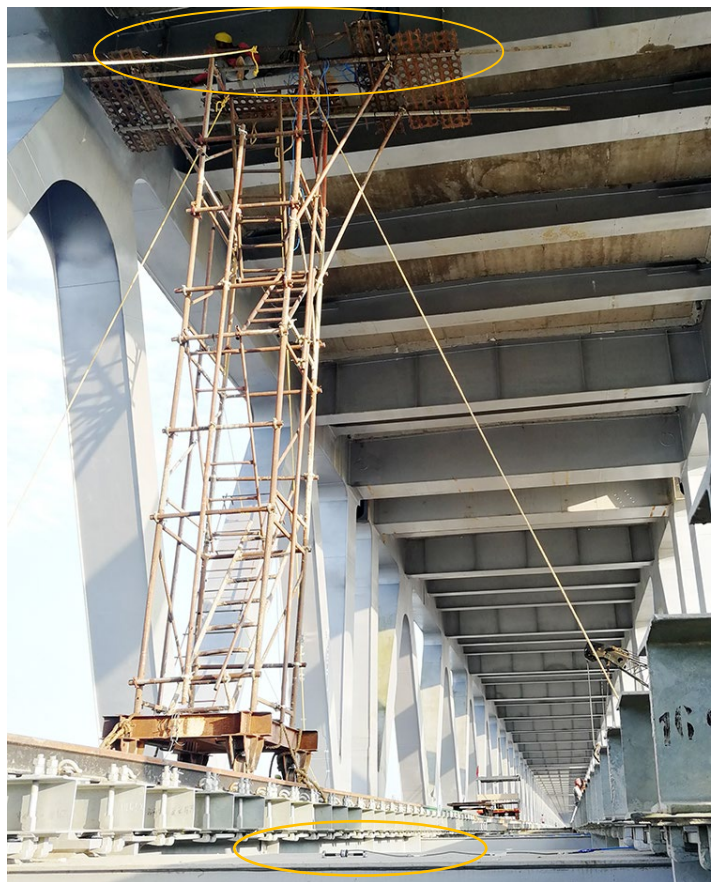
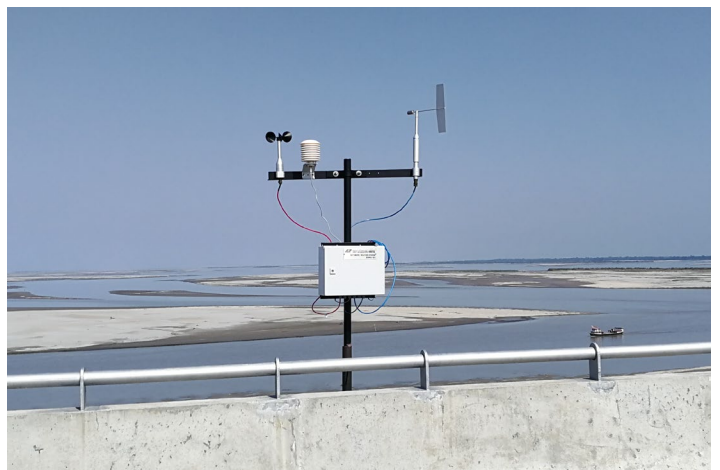
Strain gage	Used on the midpoints/endpoints of trusses as lower main chords, diagonals and top cross girders for strain measurement.
Thermocouples	Used on midpoints of trusses as lower & upper main chords for measuring steel surface temperature and also concrete temperatures at the underside of concrete deck.
Displacement Sensors	Used to monitor displacement at the center line of bearing (fixed and free) and structural member of the truss and also across the expansion joints between the two spans.
Prism targets	Used on the selected lower main chords to monitor X-Y-Z movements.
Automatic Weather Station	Used to monitor the wind speed, wind direction, temperature and humidity
Data Acquisition system	For automatic collection and transfer of monitored data to cloud server with web based data management software

A good amount of ground work had to be done to achieve such results. Installation of 170 strain gauges, 124 thermocouples, 6 displacement sensors, 8 prism targets on the top cross girder mains and intermediate, diagonal girder, bottom chord girder of the normal span and end span, in a short span of time was a challenge. Automatic weather station was installed at the center of normal span to monitor the complete weather parameters to correlate the sensor output. All the installed sensors, including weather installed were connected to Automatic Data Acquisition system for real time data at stakeholder's desk.

Another installation challenge was to install arc weldable strain gages without welding, as welding was not allowed on the truss members. Special epoxy was then used to install the strain gages on the surface of the truss members. The special epoxy selected had two special characteristics:

Special arrangement were designed to install displacement sensor at fixed and free bearing, above the pier of the bridge.

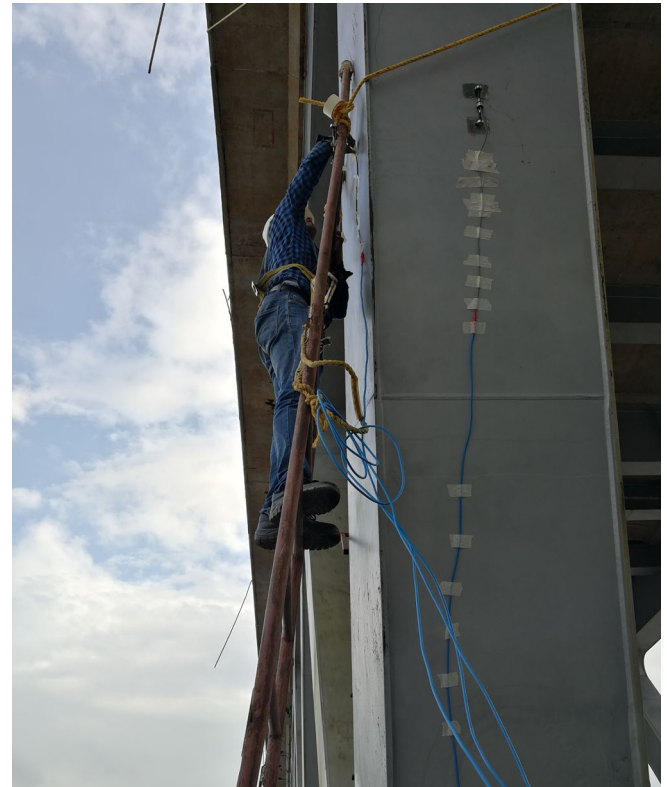
Installation of strain gage at diagonal girder

- transfer the strain (of the truss member to strain gage) without any interference or absorption for accurate result
- quick setting, such that the mounting blocks were fixed on the steel surface within 5 minutes. This helped in fixing the strain gage on the mounting blocks in single attempt, as it was difficult to reach high locations again.

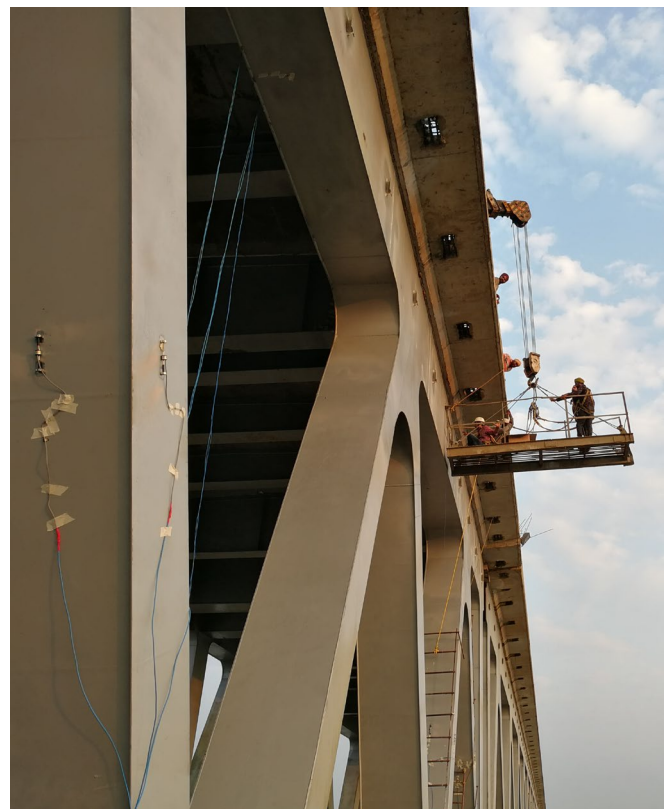
Installation of thermocouple at top cross girder

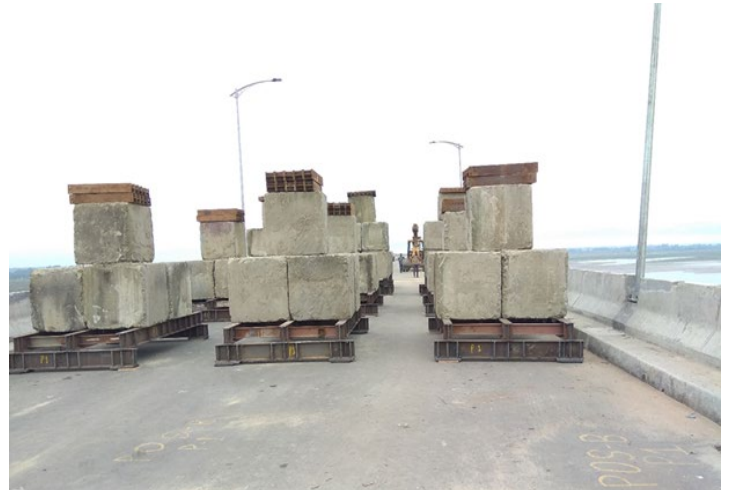
Deck loading

For deck load testing, the loading was increased gradually by placing concrete blocks and structural pieces loaded on the structural frames at designated locations. The variation in the strain distribution through the structure, displacement and geometry profiles of the bridge and the ambient temperature, concrete temperature and steel temperature in the body was noted during the loading and unloading and the full load and no load was monitored for 24 hours. Longitudinal displacement of bearings and expansion joints were also noted.

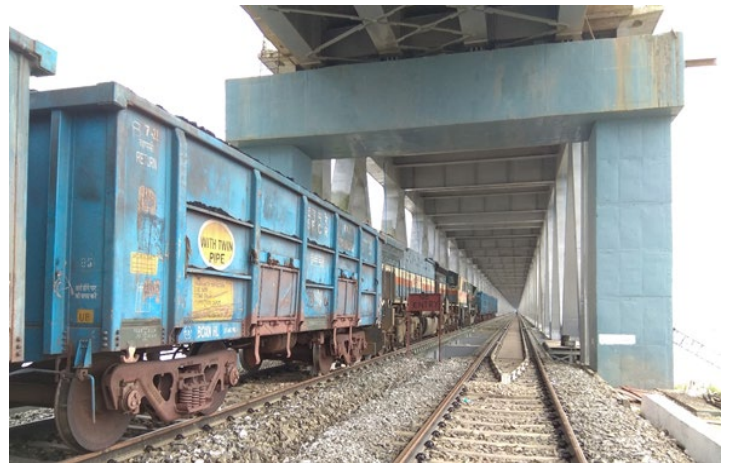
Track loading

For track load testing, the loading was provided in the form of the train engine and wagons. The load procedure followed was similar to the deck load testing and similarly the variations in all the instruments installed on the steel structure, bearings and expansion joints were monitored.

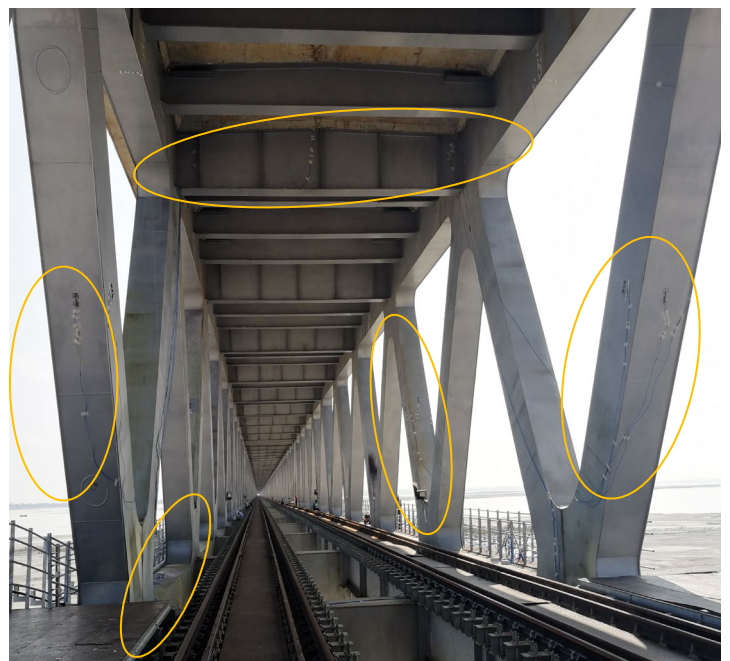
Strain gages and thermocouple installed on bridge

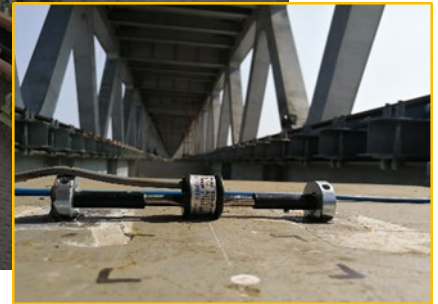
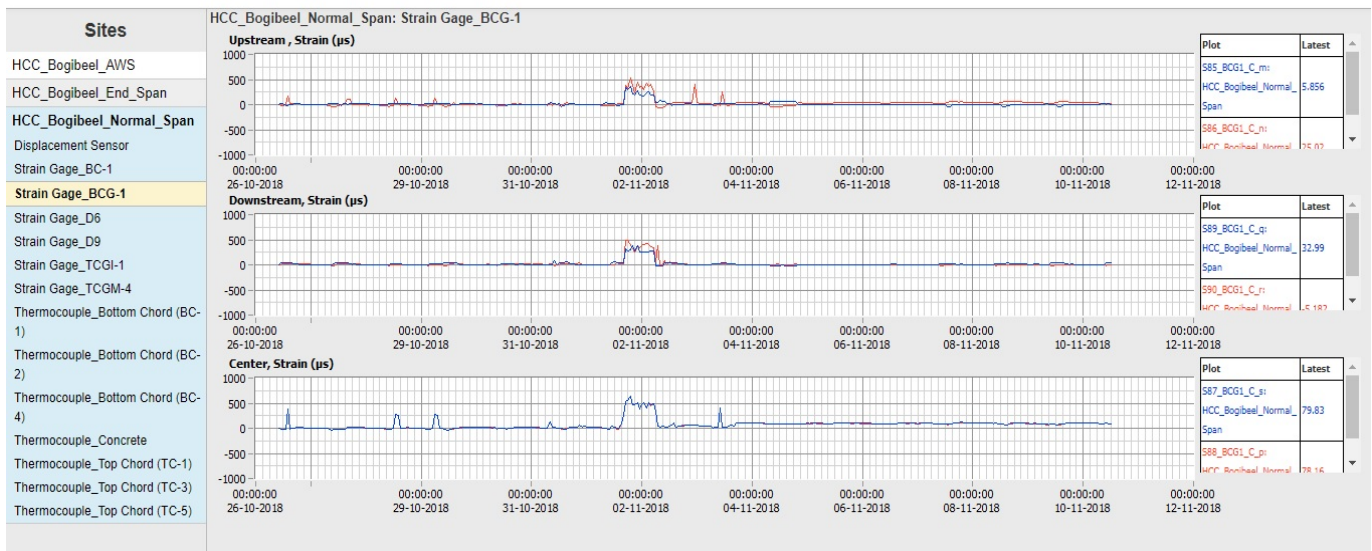
Strain gauge installed on Bottom Chord Girder of Normal Span showing variations in strain during the Load test

For e.g. the strain and displacement varied along with the combined effect of load applied and the ambient temperature. Increased load applied on the structure increased the strain, displacement on various components of truss like diagonal girder, top cross girder mains and intermediate, bottom chord girder. Few typical results are shared below.

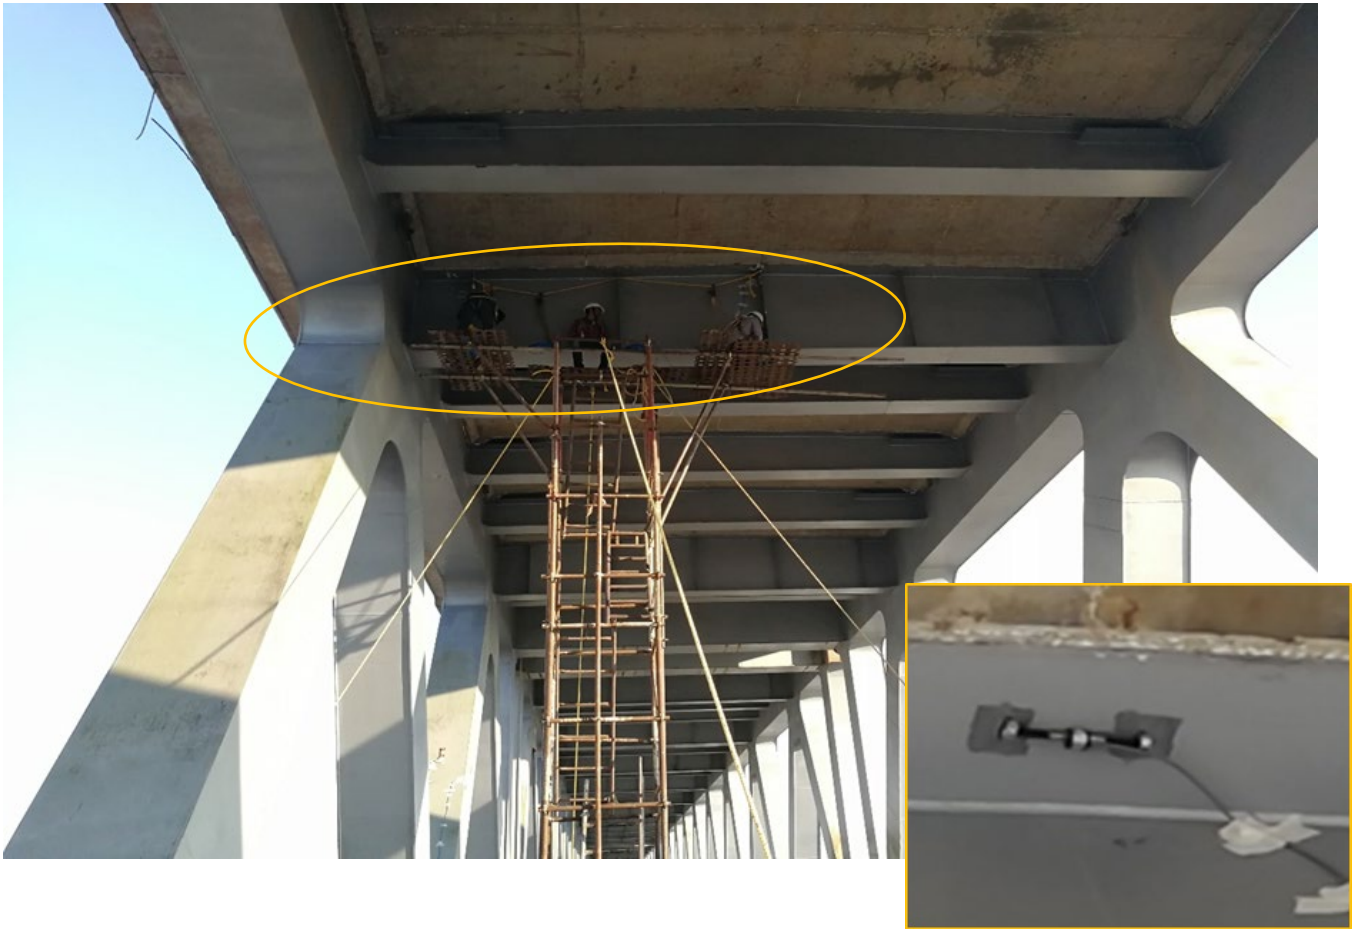
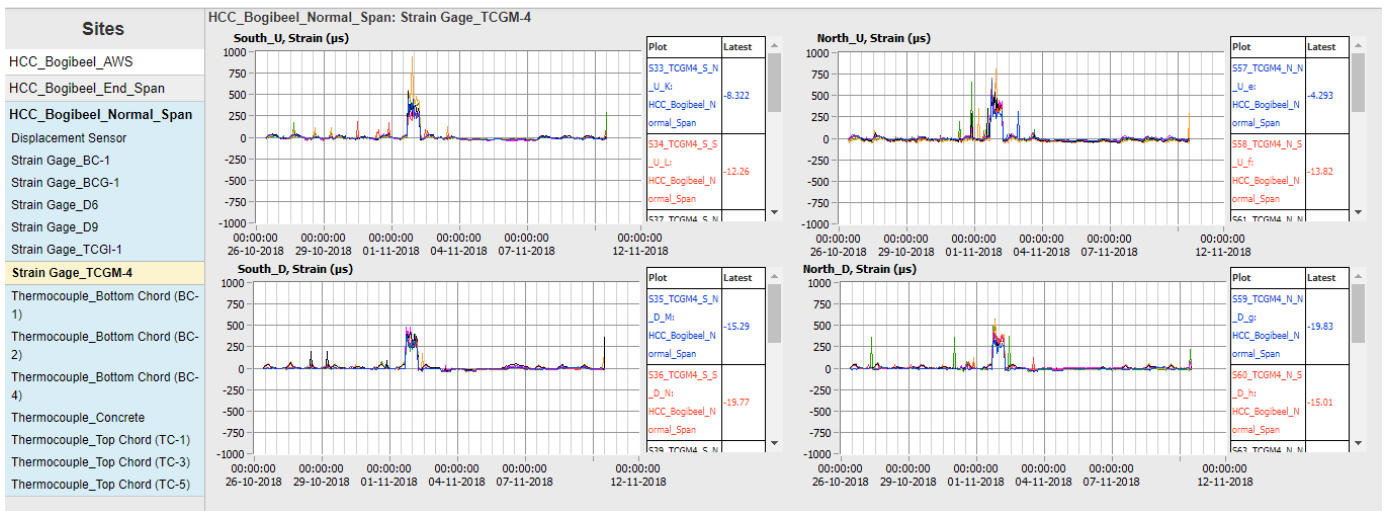
Strain gauge installed on Top Cross Girder Main of Normal Span showing variations in strain during the Load test

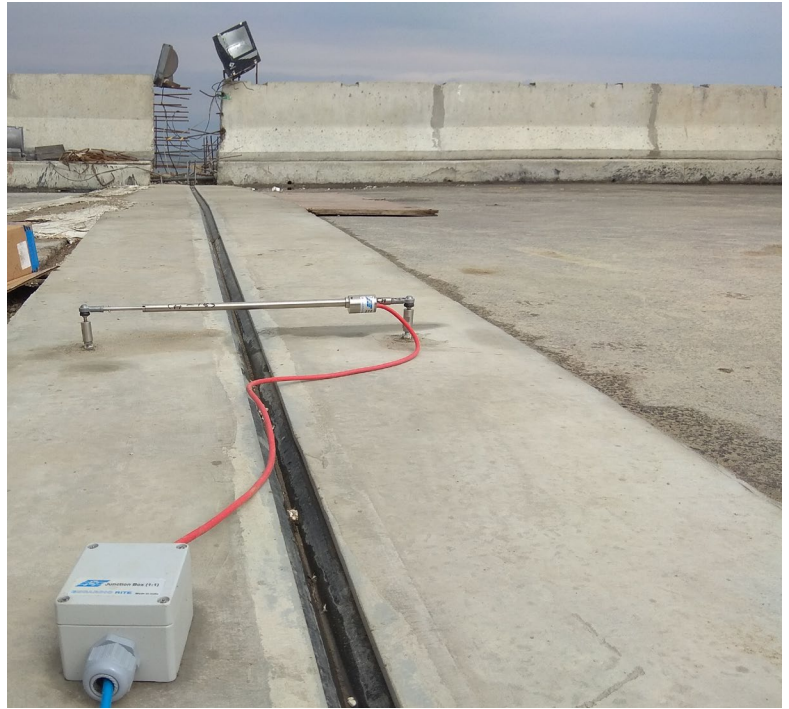
Displacement sensors installed to measure free and fixed bearing movement and expansion joints

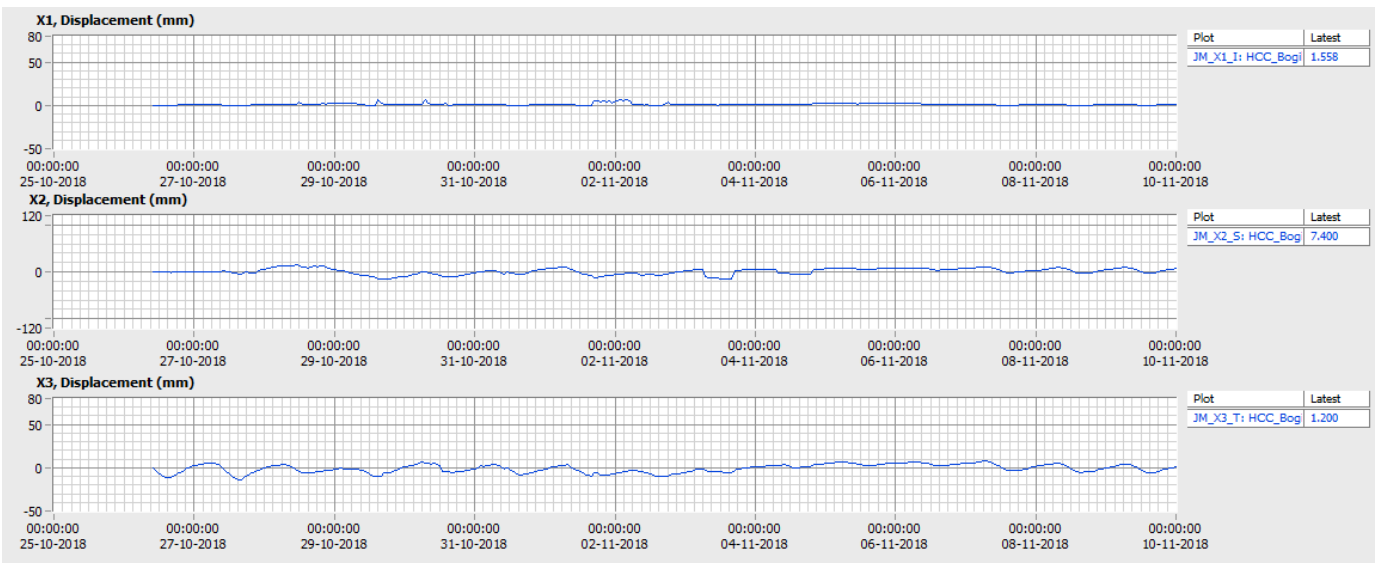
Displacement variations during the Load test

Overall the effect of the day temperature (high), sunrise, sunset and night temperature (low) along with wind on strain measurement (steel surfaces of girders), displacement measurement (of expansion joints, fixed and free bearings) and temperature measurement (of steel surface and underside of the concrete deck) showed results as per the expected variations.
